CONCORD WALL[®] / ROMAN WALL[®]

REF: Detail_Concord Wall_Roman Wall_Steps

STEP DETAIL

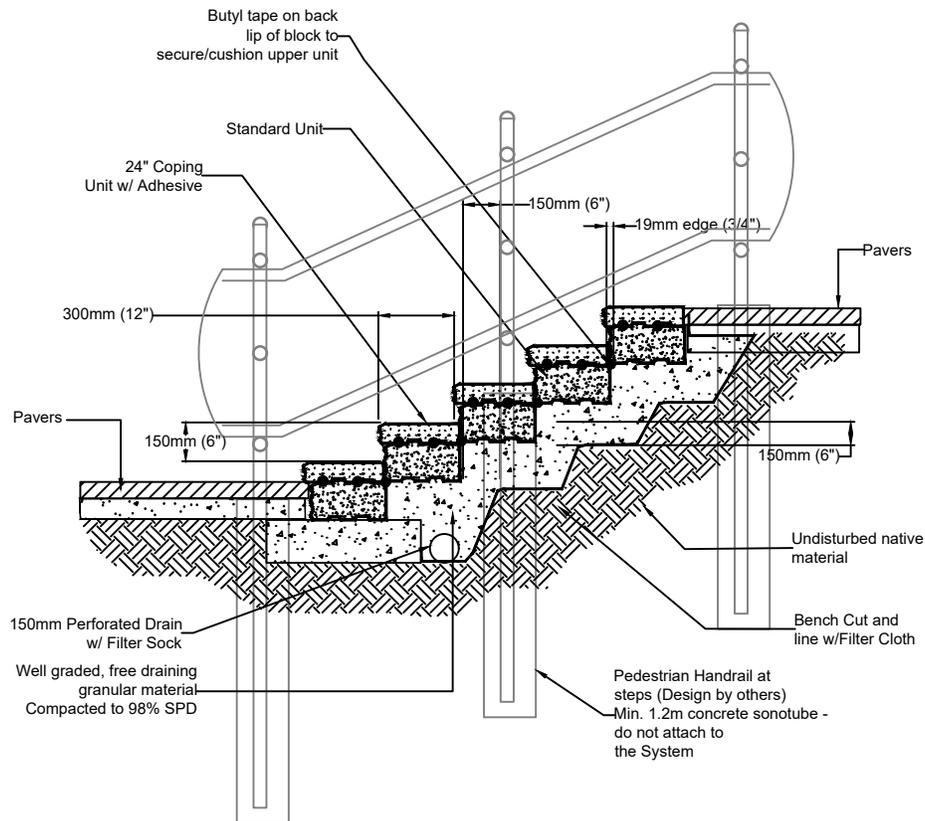
Note: Poor site conditions can affect the stability of the structure. Consult a qualified professional engineer to determine site specific construction details.
